## RAILWAY INVESTIGATION REPORT

R00Q0023

### MAIN-TRACK DERAILMENT

Canadian National  
Train No. M-365-21-20  
Mile 9.58, Saint-Maurice Subdivision  
Cressman, Quebec  
22 May 2000

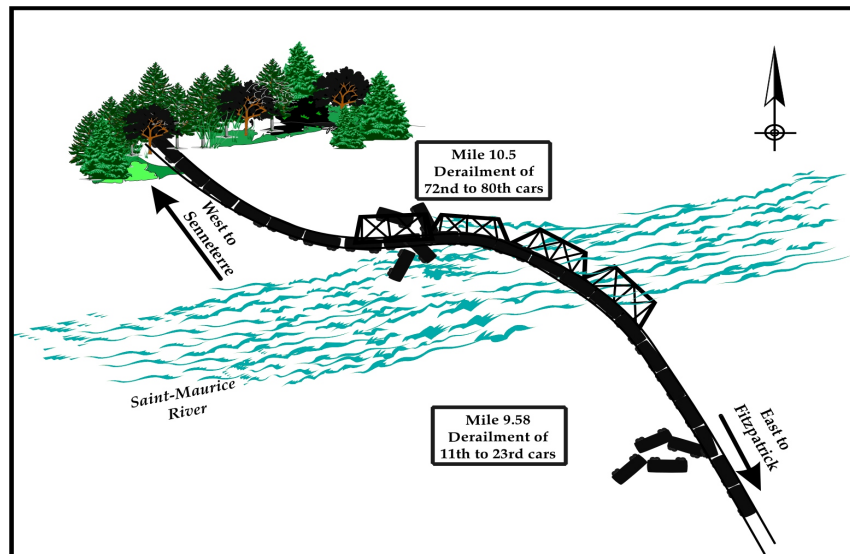
Figure 1. Overall view of occurrence site

Some 400 feet of track was destroyed and two spans of the bridge were heavily damaged. One hopper car, 2 covered cars, 13 gondola cars and 6 tank cars were damaged. The hopper car was destroyed. All the damaged tank cars were 111A cars—the head of the tank on two of the tank cars was punctured, the head of the tank on another was deformed, and the shell of the three others was deformed. Damage to the top fittings was noticed on one of the tank cars.

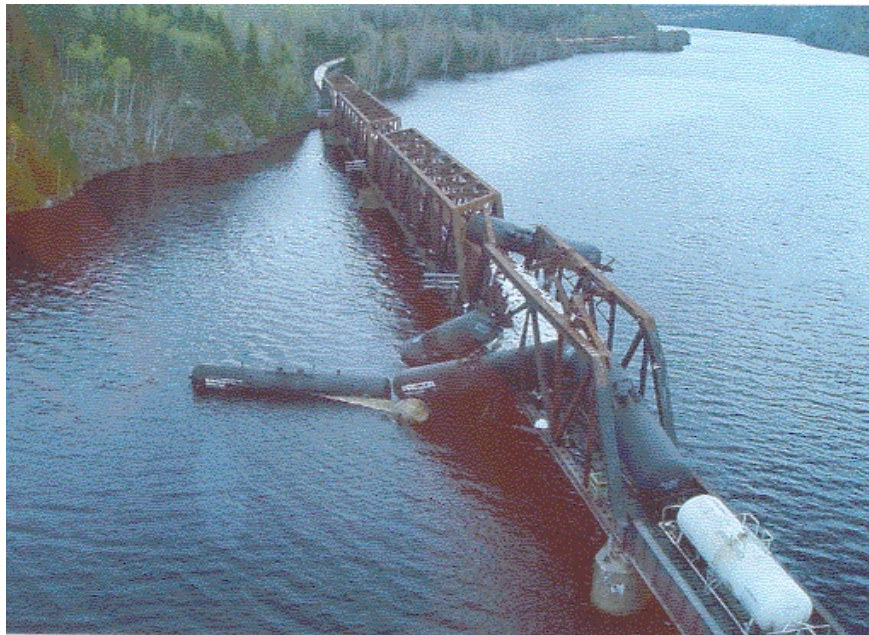
The hopper car and the empty tank cars were placed near the middle of the train (74th to 80th cars). The weight ahead of these cars was approximately 7 000 tons, and the weight behind was approximately 8 700 tons. The hopper car and three tank cars fell off the bridge and another tank car was left hanging from the bridge structure (see Figure 2). The hopper car was a cylindrical pressure-flow car with three outlet valves and no centre sill, and was constructed of 3/16-inch plate, Class AAR C-612.

**Figure 2.** View of derailment on the bridge (72nd to 80th cars)

The derailment of the 72nd to 80th cars was a result of the first derailment, which occurred at the head end of the train. When the 11th to 23rd cars derailed on the broken rail, the emergency brakes applied. The empty cars in the middle of the train were caught between the block of loaded cars at the head of the train, which were decelerating due to the braking force generated by emergency braking, and the sudden pile-up of the derailed cars and the cars behind them, whose brakes had not yet been applied. Due to the weight of the block of cars in the tail end of the train and the speed they were travelling, the resultant inertia applied high compression forces to the couplers, which led to the second derailment. Since the hopper car was empty and of light construction and had no centre sill, it was more vulnerable and consequently yielded first. Based on the damages observed on the hopper car, it was deformed by compression forces, was lifted, and struck the top chord of the bridge superstructure; the tank cars behind the hopper car piled on top of it, damaging the bridge structure and the covered cars further ahead.
